**REPORT OF INVESTIGATION
INTO A FATAL INCIDENT
TEMPLENOE, KENMARE BAY,
CO. KERRY
ON
31st JANUARY 2016**

**REPORT NO. MCIB/252
(No.9 OF 2016)**

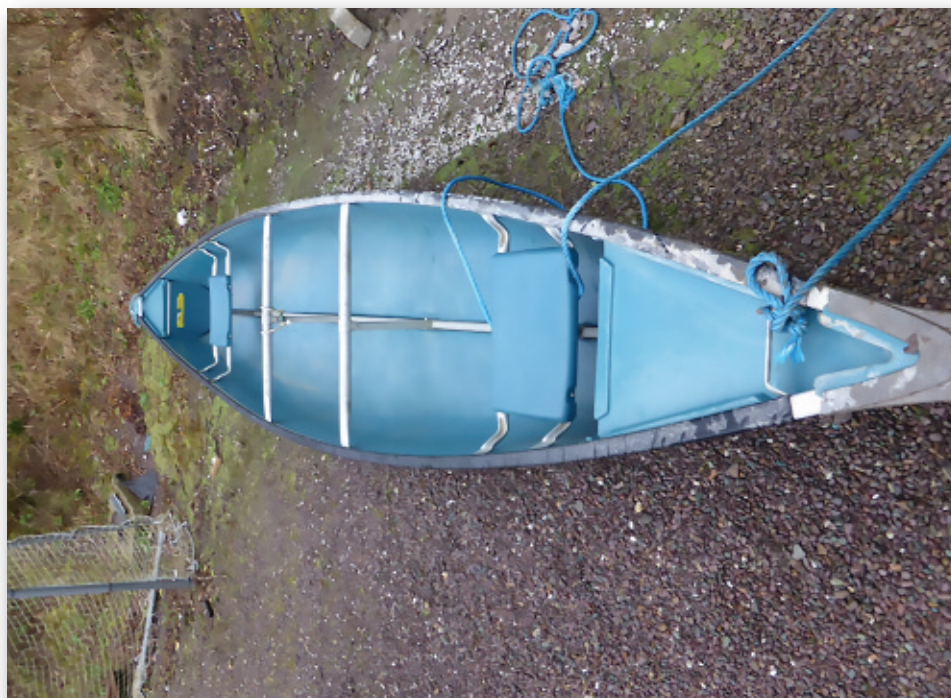
Photograph No. 1: General view of vessel internally.

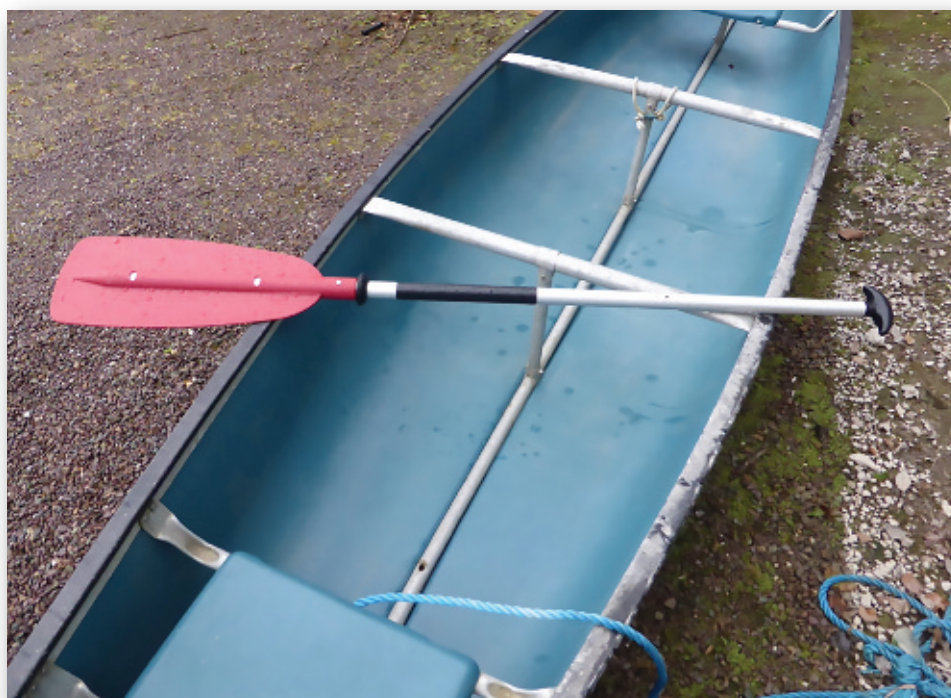
Photograph No. 2: Paddle used for propulsion.

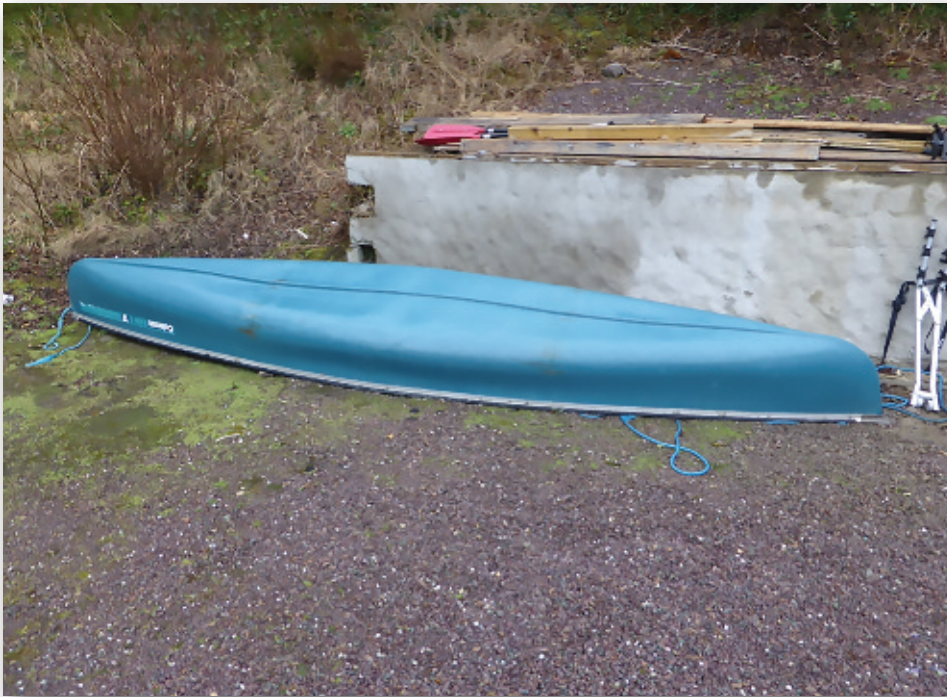
Photograph No. 3: Bottom of vessel.

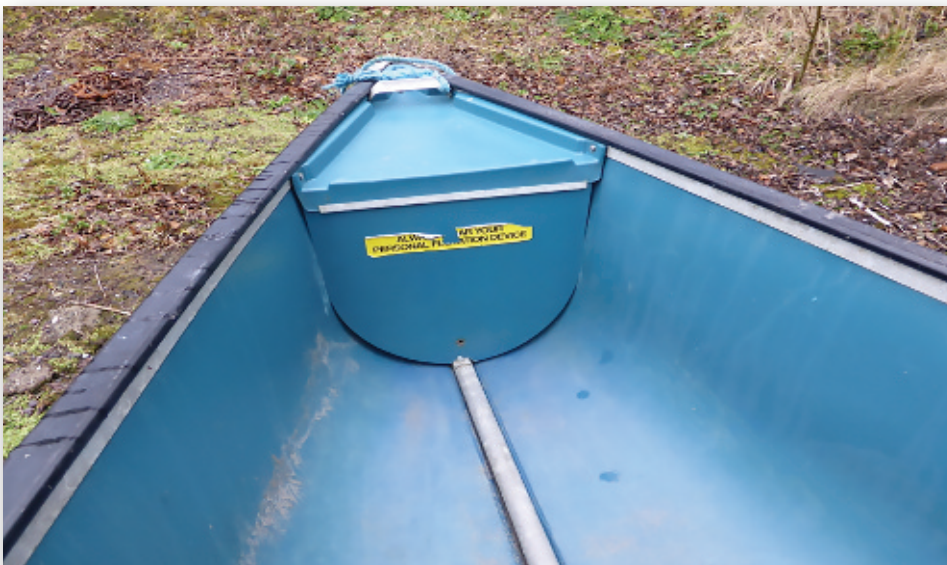
- 4.2 When canoeing one should always wear a floatation device, never paddle alone and always be aware of weather conditions.
- 4.3 There was a placard in the vessel stating “ALWAYS WEAR YOUR PERSONAL FLOATATION DEVICE” (see Appendix 7.1 photograph 4). In this incident, neither of the men were wearing a floatation device.

Photograph No. 4: Notice in Canoe stating "ALWAYS WEAR YOUR PERSONAL FLOATATION DEVICE"

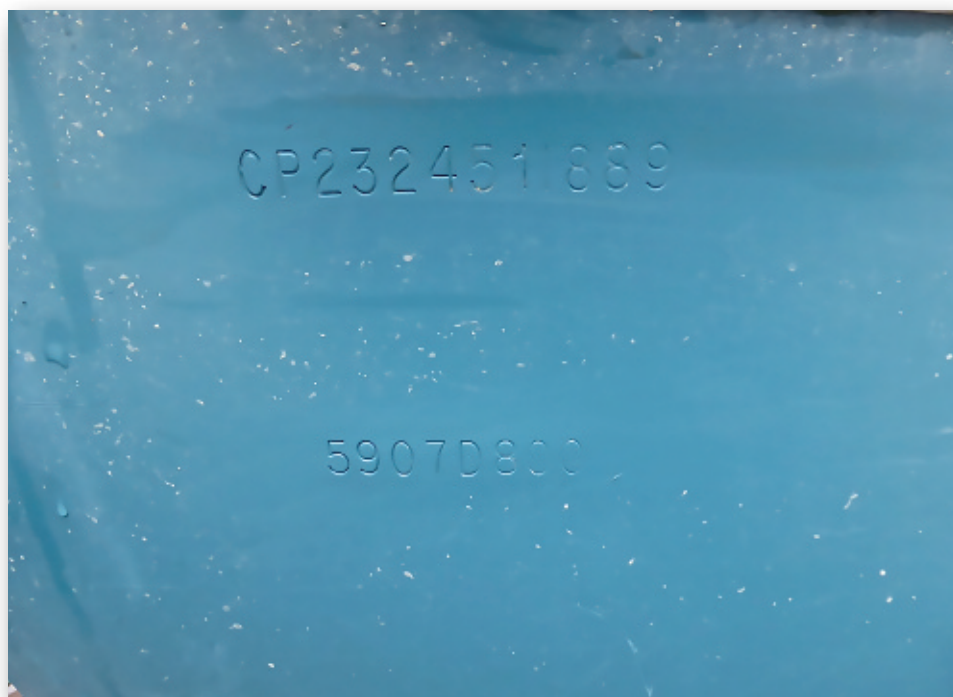
Photograph No. 5: Hull ID No. & Serial No. on the vessel.

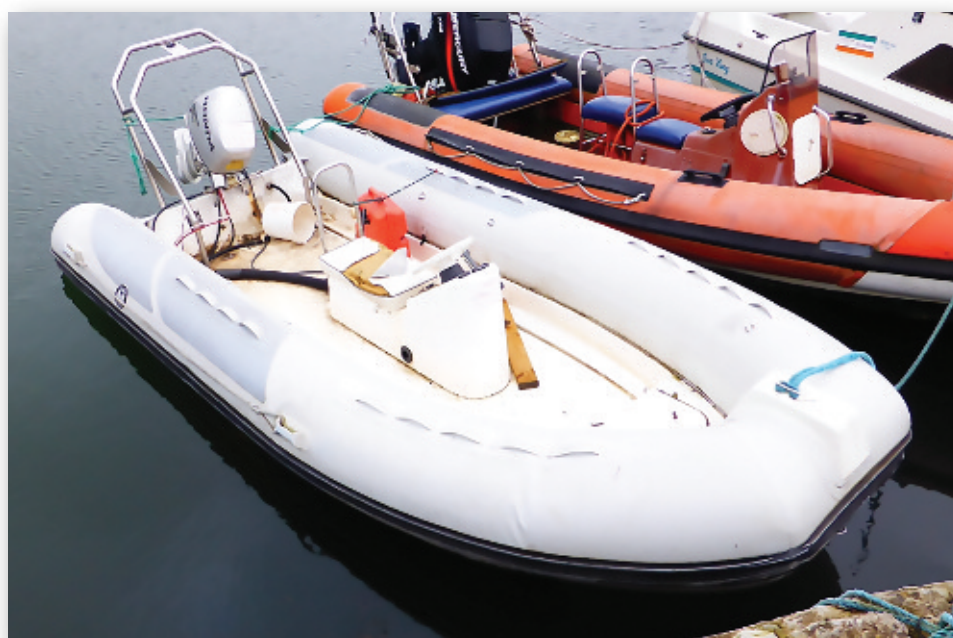
Photograph No. 6: Vessel used by Fire Brigade during initial response.
