**REPORT OF INVESTIGATION
INTO A FATAL INCIDENT
TEMPLENOE, KENMARE BAY,
CO. KERRY
ON
31st JANUARY 2016**

**REPORT NO. MCIB/252
(No.9 OF 2016)**

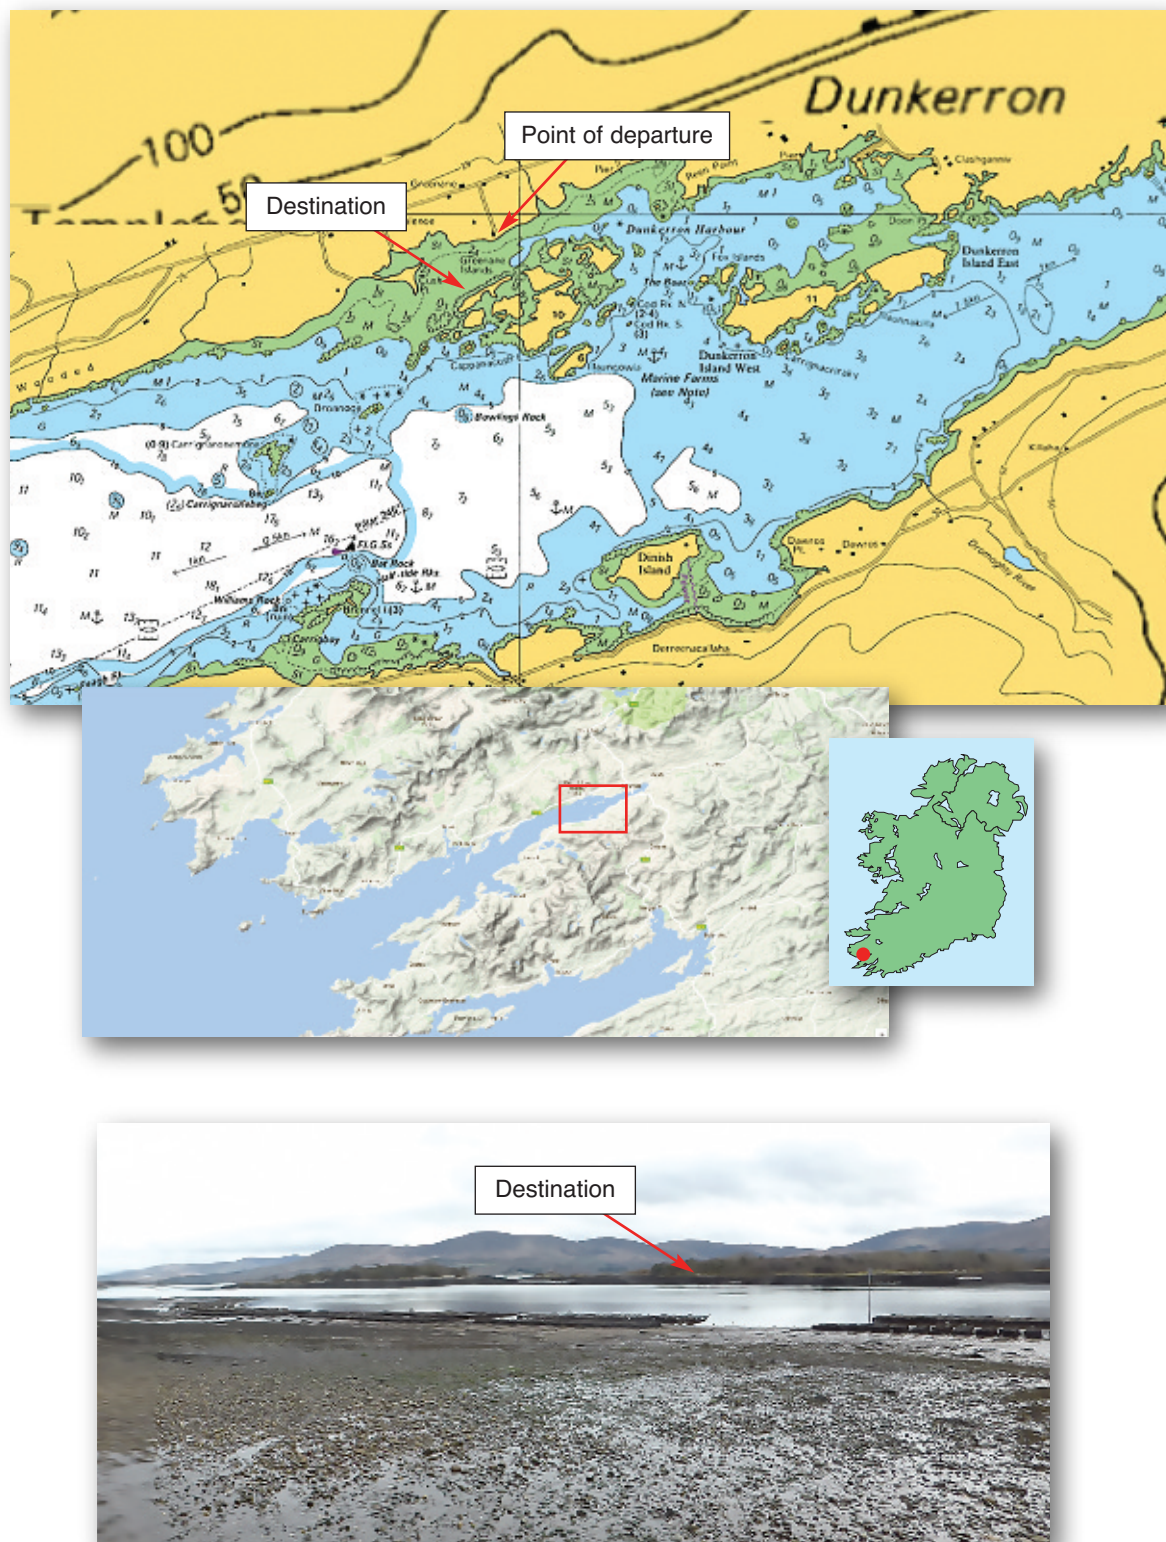
Appendix 7.2 Location of Incident.

Launching Location,
From launching location to destination a distance of approximately 250 m.
Photograph taken at similar tidal conditions to casualty.
